Project NY 300 Olo Technical Note N-218 25 April 1955

interim technical note

DEVELOPMENT OF A PORTABLE DECONTAMINATION SHOWER UNIT

U. S. Naval Civil Engineering Research and Evaluation Laboratory Port Hueneme, California

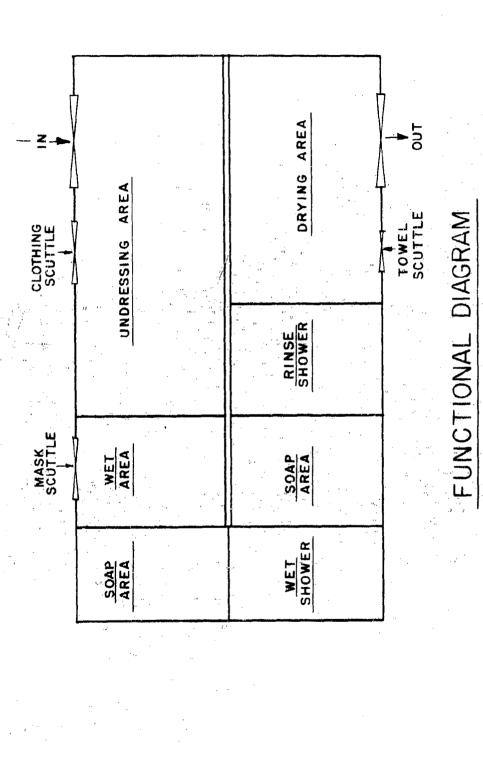
F1G. 1.

The basic showering procedure selected for this unit is based on previous work by Camp Detrick and this Laboratory. Each individual will go through the following compartments (see figure 1), in sequence to perform the indicated operation:

- 1. Undressing room
- 2. Rinse shower stall
- 3. Soaping stall
- 4. Rinse shower stall
- 5. Soaping stall
- 6. Final rinse stall
- 7. Toweling room

One minute is allowed for each person in each section except the undressing rob where space allows each person to spend two minutes.

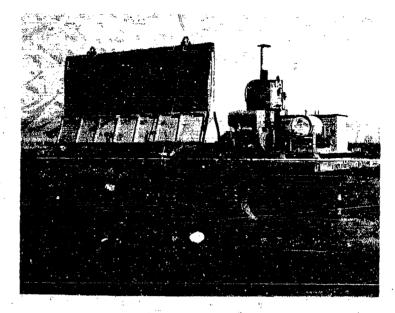
The unit, as designed, consists of three major components: the shower shelter, the water heating and treatment section mounted on a pallet, and an engine-generator set to supply electrical power. Figure 2 illustrates the three sections on a flat bed trailer for transport.

Figure 2. Shower unit loaded for transport.

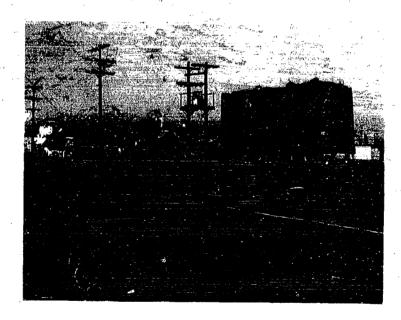
The shower shelter is based on a rigid center frame with a skid base 2 1/2 feet wide. Canvas is used for the walls and roof. To open the shelter from its collapsed position, the floor panels are folded down and the compartment separators are folded out to support the canvas in the shape shown in Figure 3. Figure 4 shows the towel shelves and the compartment separators in the in-service position. Figure 5 shows one of the shower compartments and a soaping compartment.

Figure 3 . Shower shelter after erection.

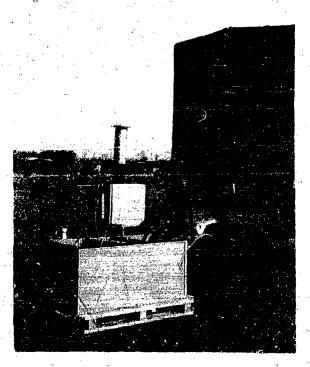
The water tank is used to allow approximately 10 minutes chlorine contact time for the circulating water before it is passed through the heater to the shower heads. Figure 6 shows the connections to and from the shower shelters. This unit required gravity drainage for return of the waste water.

Figure 6. Water connections from equipment pallet to shower shelter.

Once the shelter and equipment pallets are in place, it requires one man only a few minutes to place the unit in operation. As Figure 6 shows, the shelter must be elevated at least 3 ft to allow recirculation of the waste water. If this is not required, the relative elevation of the two units is not important, except the drainage should be away from the equipment pallet.
